# Portage Creek Sediment Remediation Project Kalamazoo, Michigan

Pre-Sediment Removal Structure Feature Assessment  
Removal Areas SA1-A, SA1-B and SA1-C

**FLEIS & VANDENBRINK  
ENGINEERING, INC.**

F&V Project Number: 809930  
May, 2013 (Updated June, 2013)

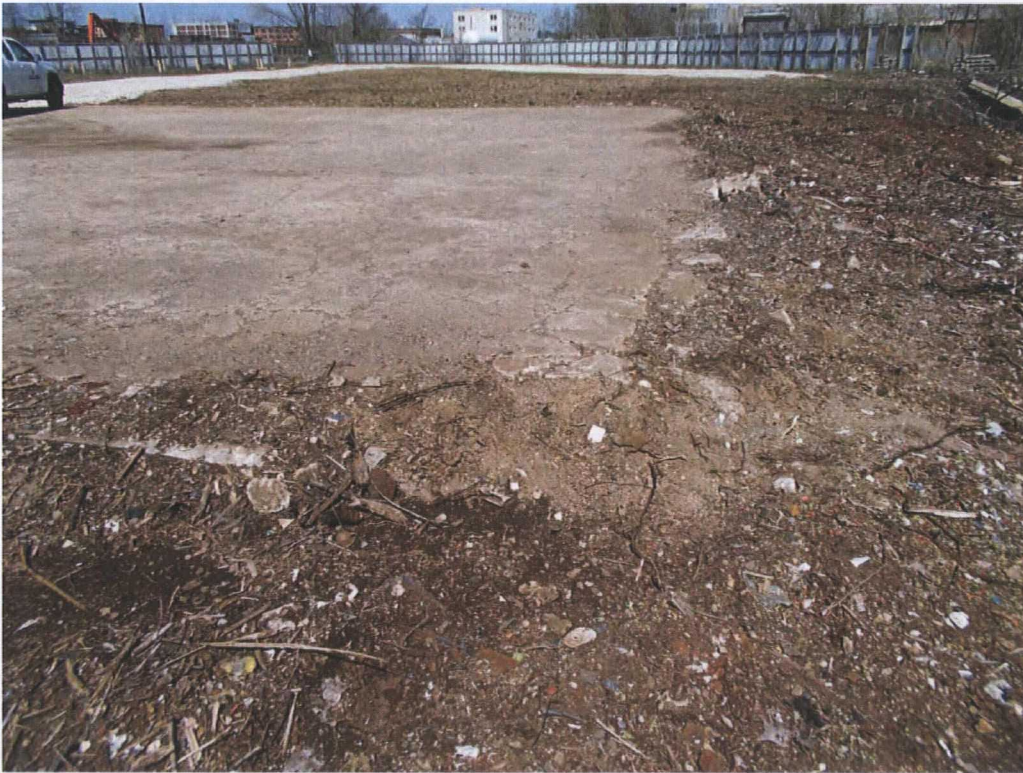
- The pavement is in critical to failed condition with alligator cracking and spalling throughout.

View of pavement looking north

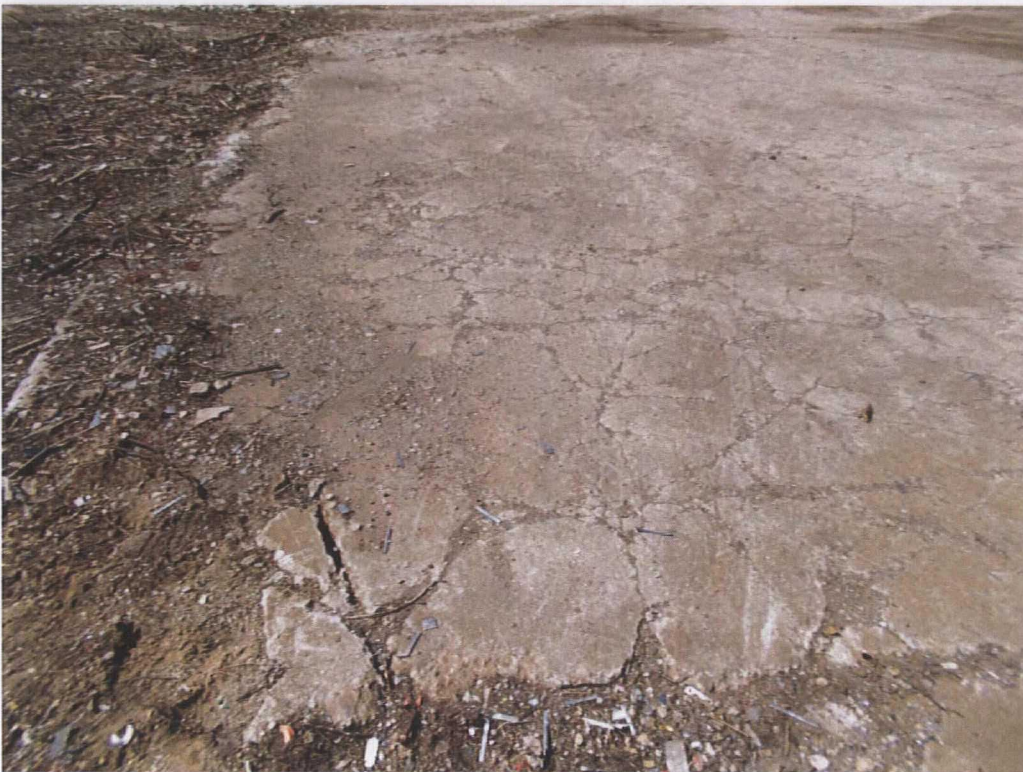
Severe cracking and spalling of pavement

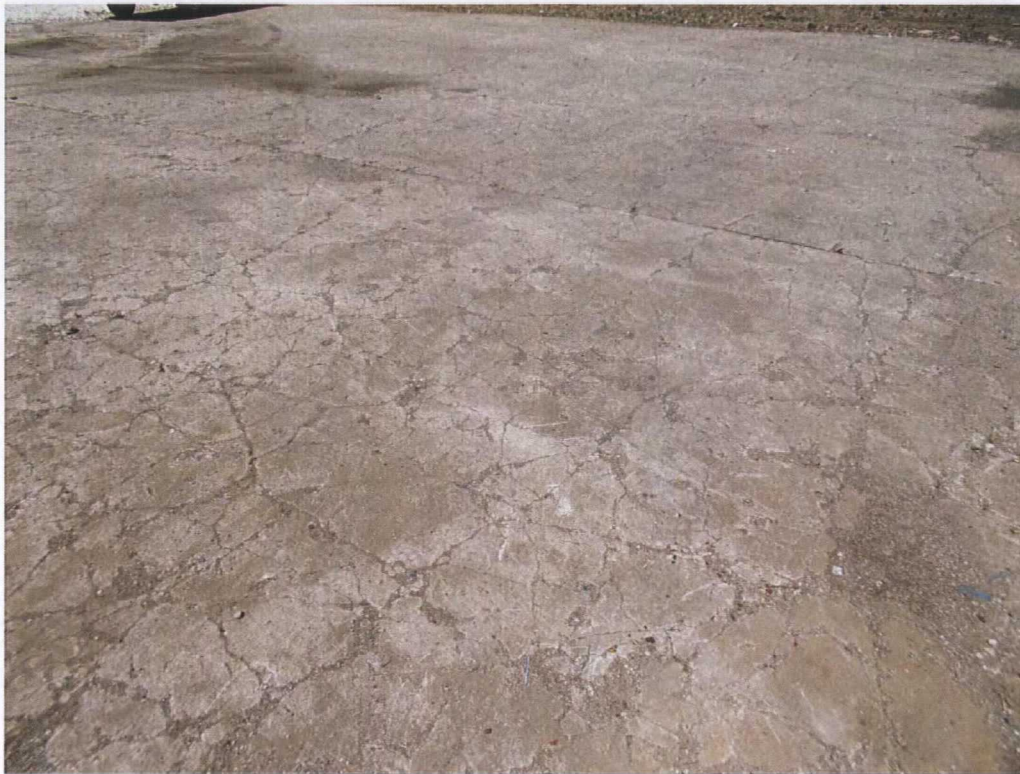
Severe cracking of pavement

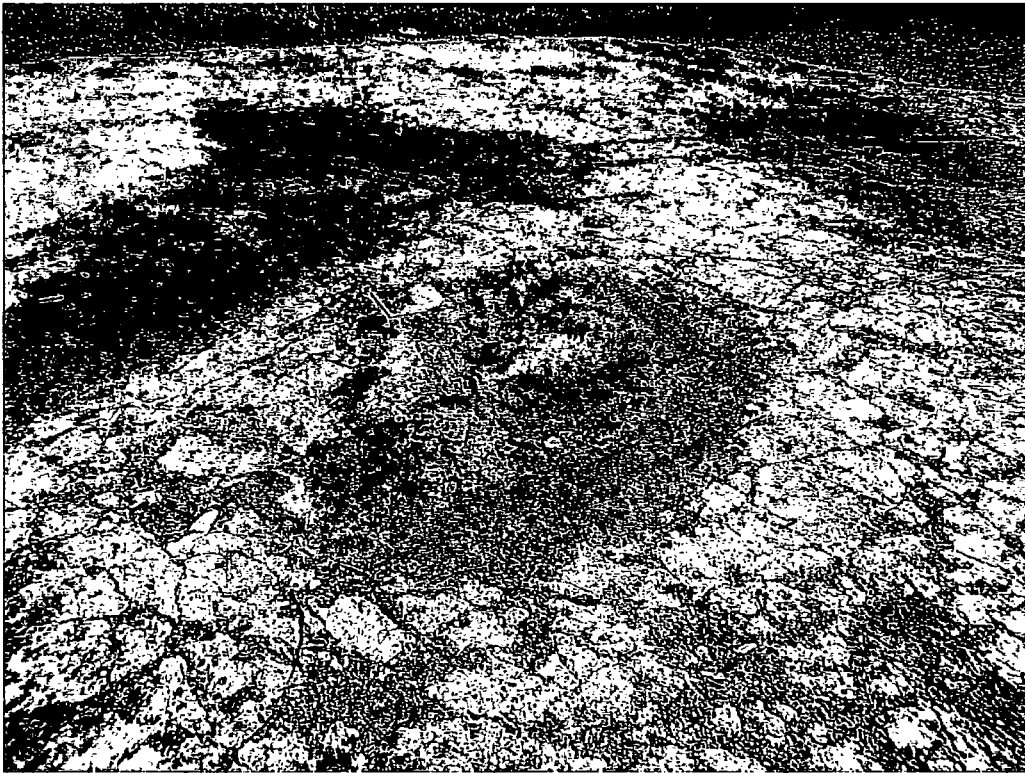
Patched area on interior area of pavement

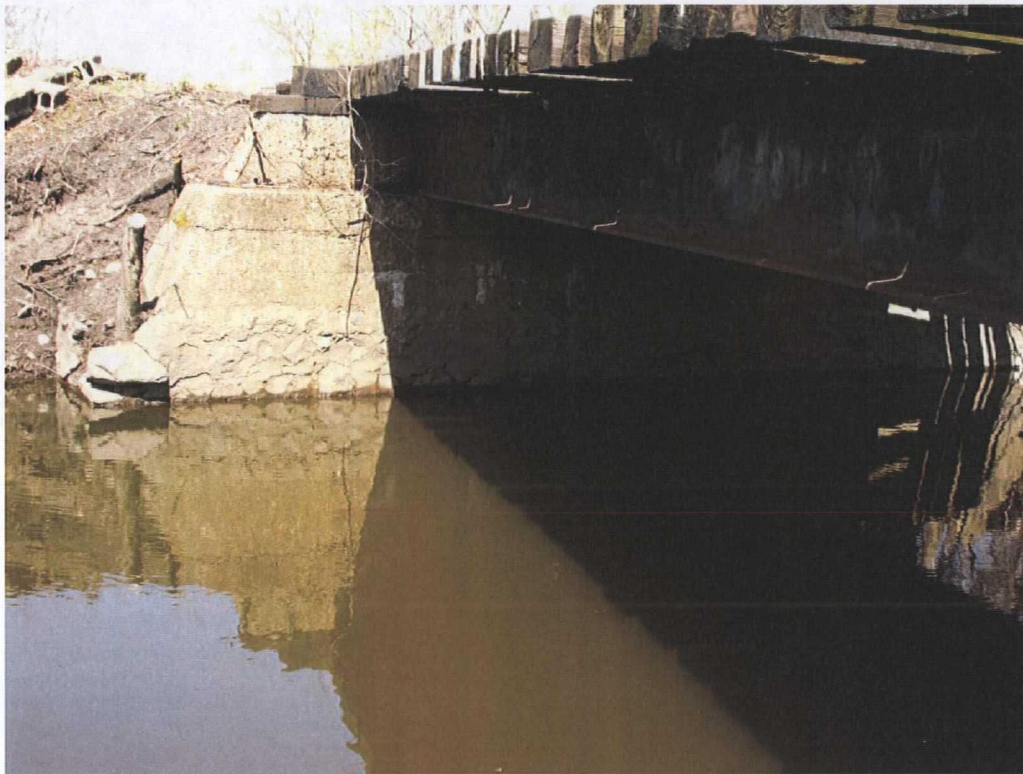
Corrosion on fascia beam

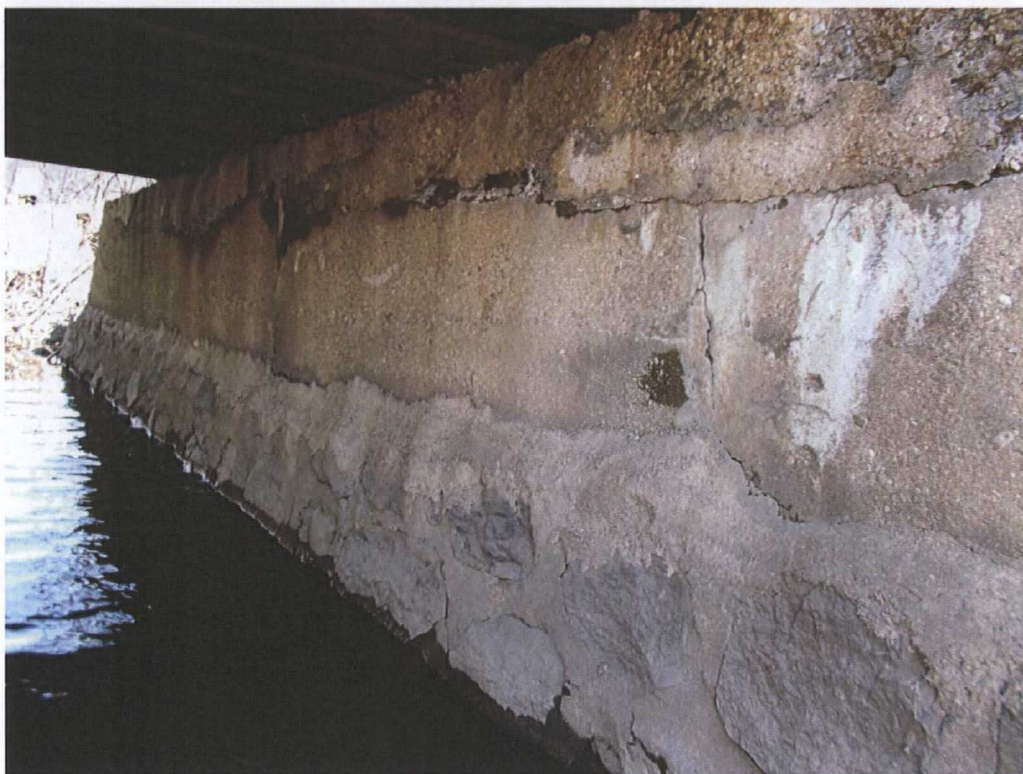
Patching on stone foundation

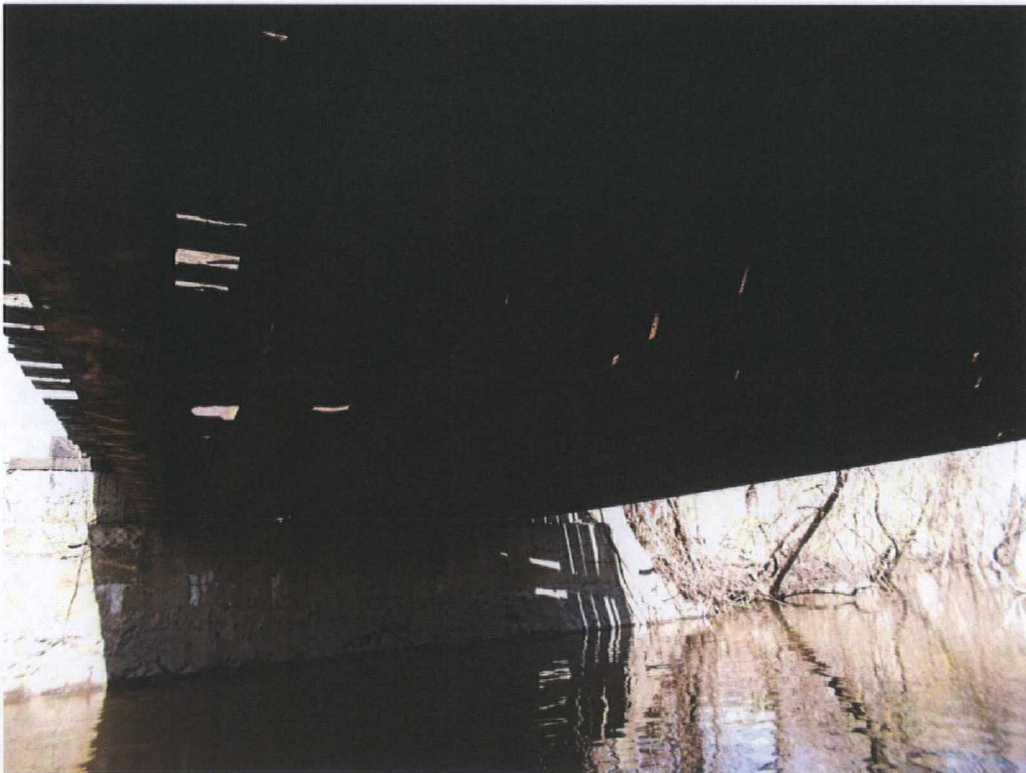
Corrosion on steel beams

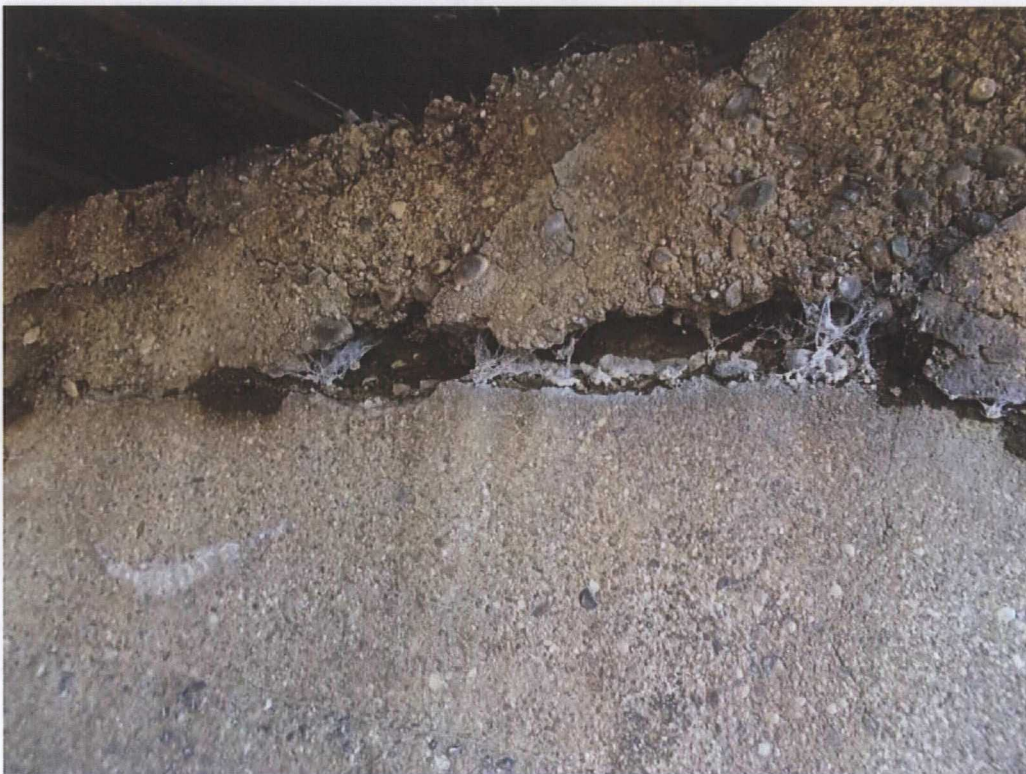
Deterioration of concrete abutment in bearing area

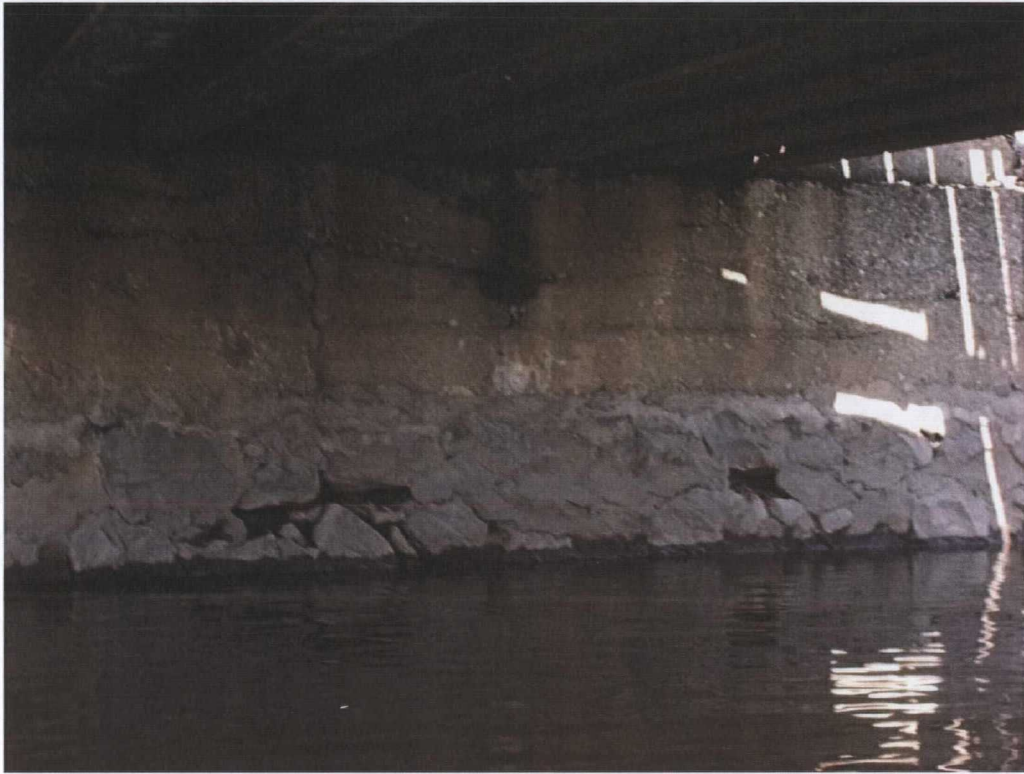
Voids in stone foundation

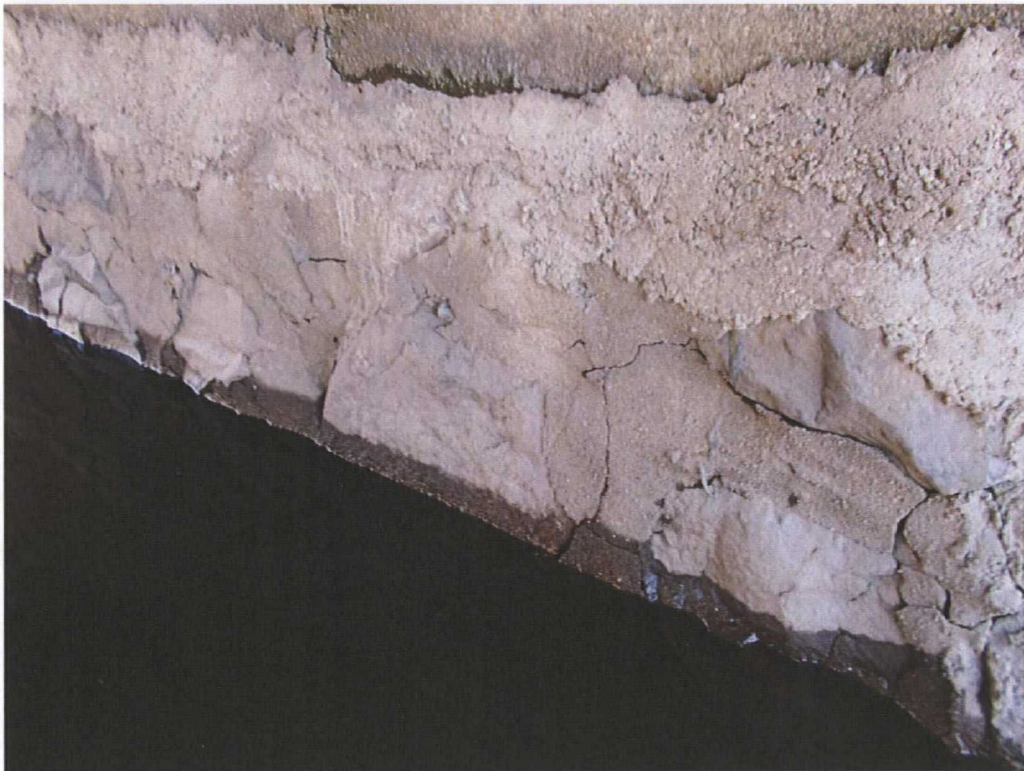
Patching on stone foundation

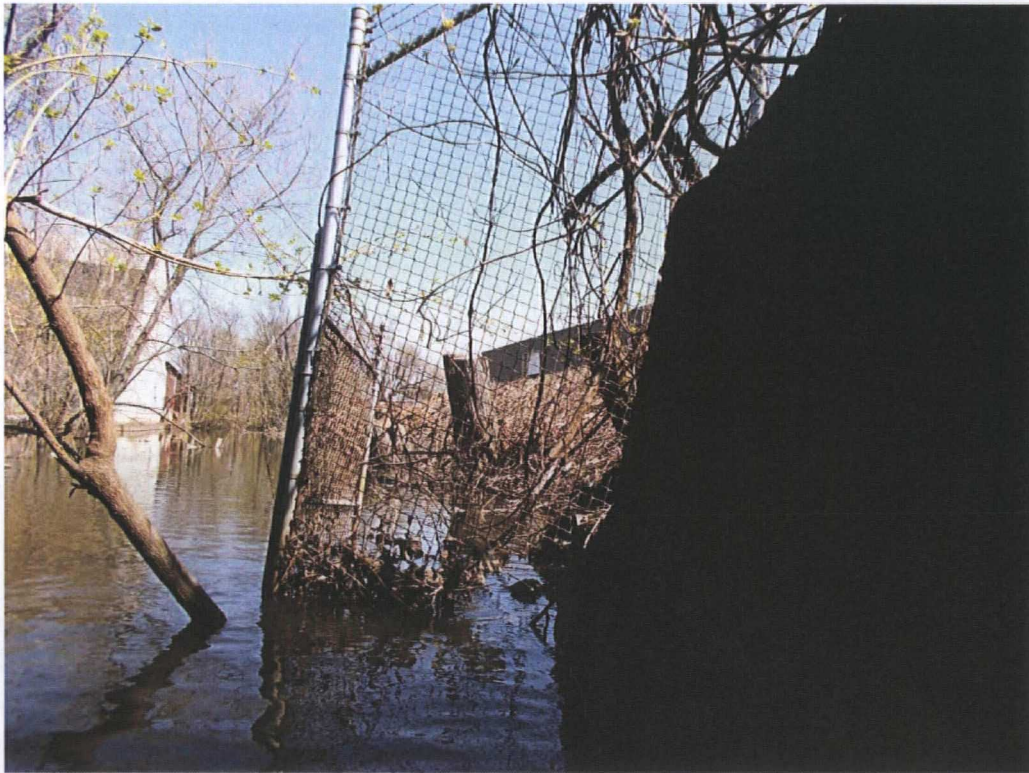
Fencing in northeast quadrant

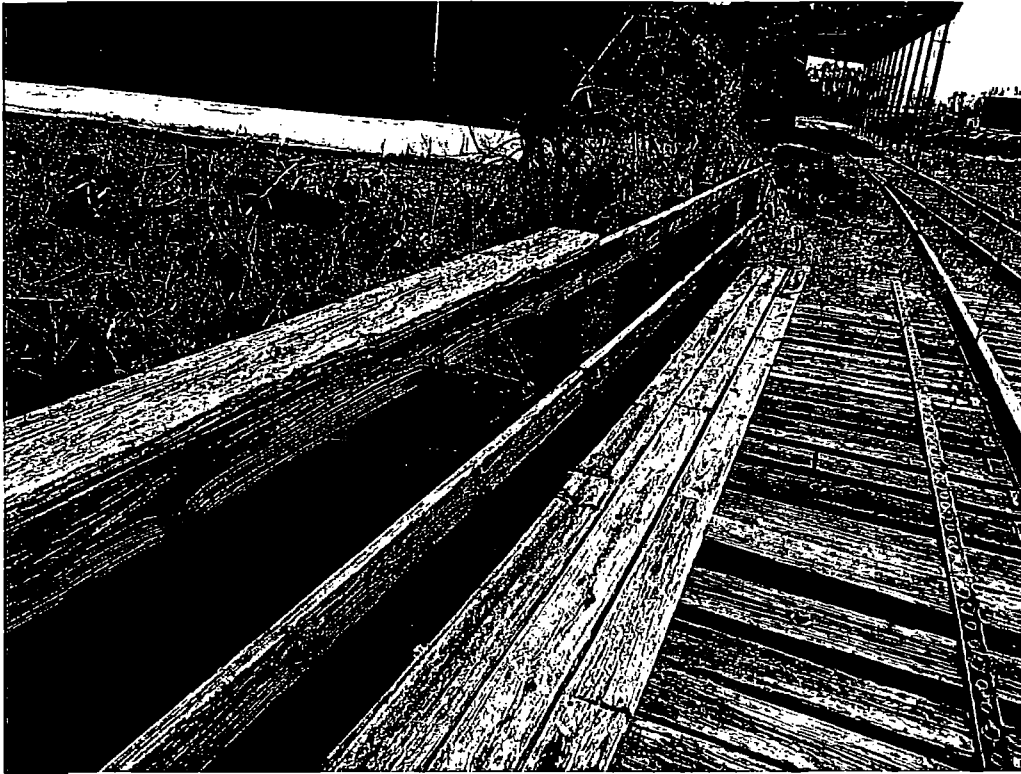
Failed top plate on timber railing
